BUILDING UPDATE

Construction Begins!

Annunciation
Cathedral • 2013

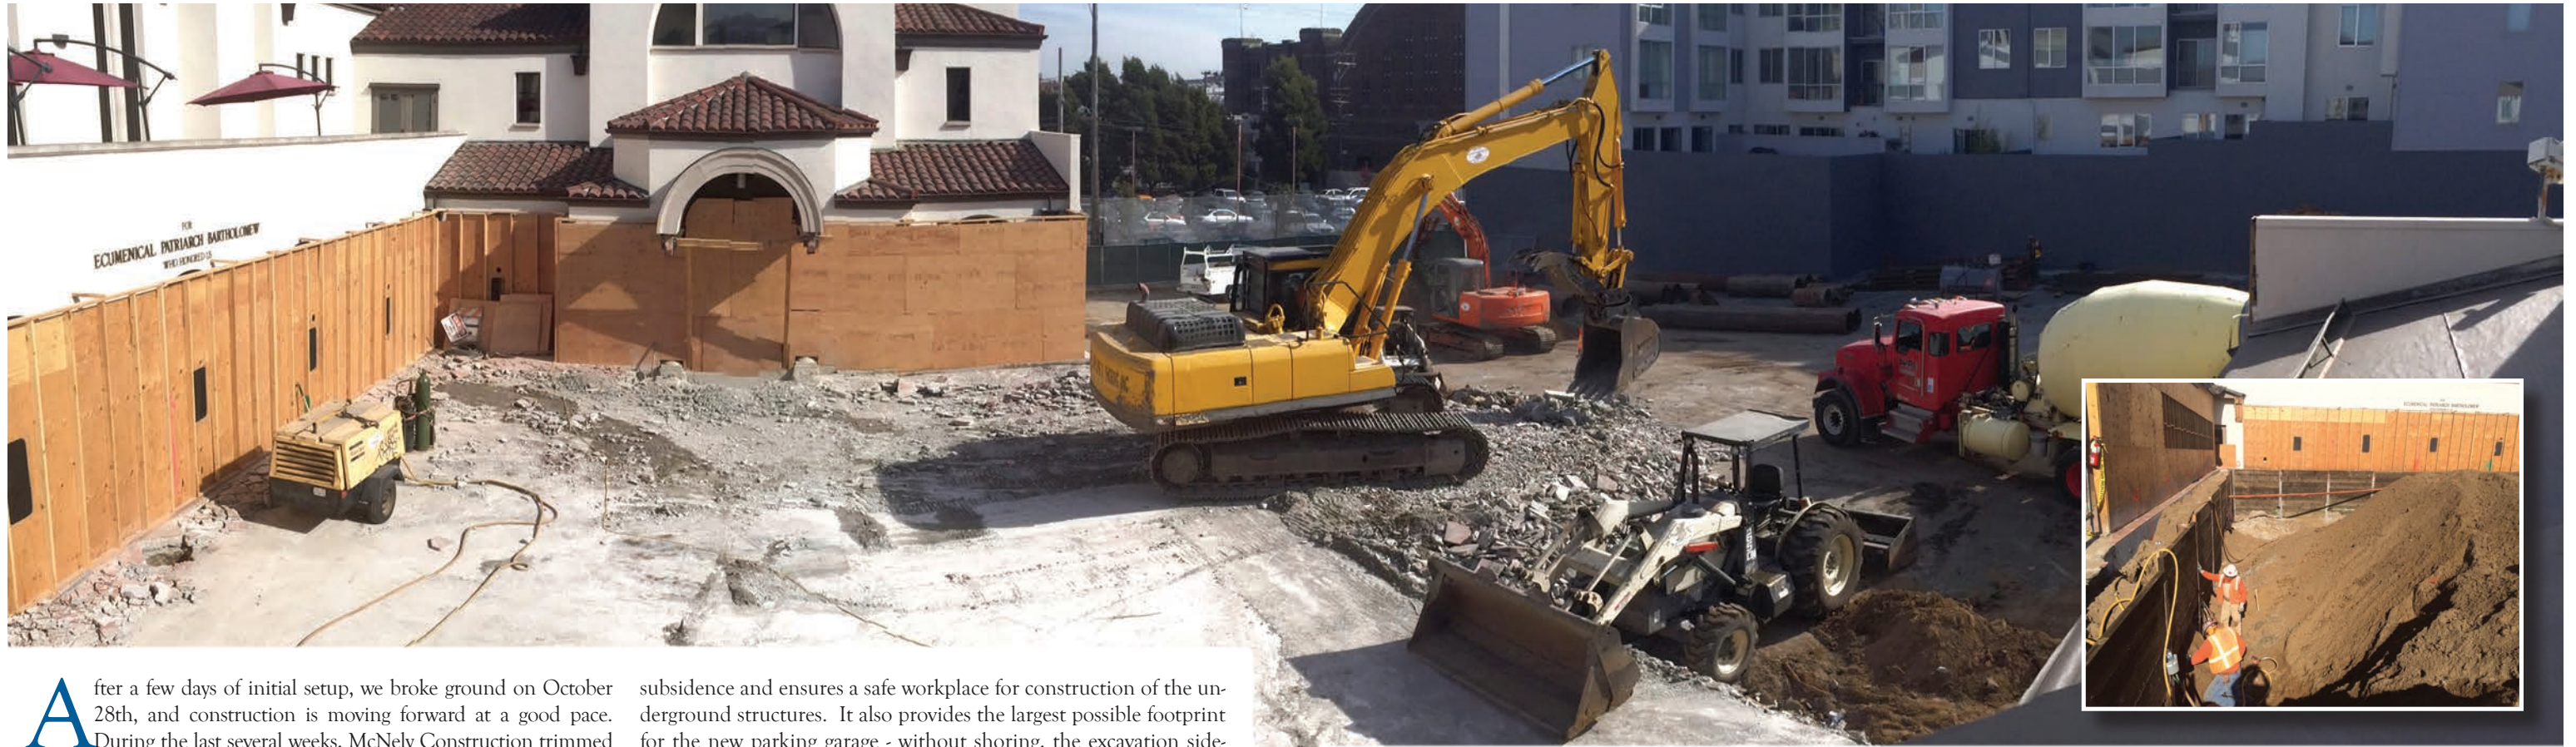
After a few days of initial setup, we broke ground on October 28th, and construction is moving forward at a good pace. During the last several weeks, McNely Construction trimmed back the covered outdoor walkway, and Granite Drilling and Shoring removed the tile from the courtyard and steps and demolished the concrete courtyard slab, steps, and half walls. They also removed the parking lot asphalt together with the parking lot lights and their concrete bases, and the fence along Stevenson Street was removed and replaced with a construction fence. During the demolition, the various materials were kept separated so that the maximum amount possible could be recycled (concrete and asphalt rubble are processed to make recycled aggregate rock for use in new concrete or under new asphalt pavement, metal can be recycled, and clean soil can be sifted and used at other sites that need fill clean fill). Recycling facilities charge less to dispose of materials than landfills, and maximum recycling was taken into account when the contractor developed the final demolition and excavation costs.

While the site demolition was progressing, Granite also set all 59 soldier piles for the shoring system. The shoring system is a kind of retaining wall, consisting of soldier piles with wooden planks (lagging) between each pair of piles; together the piles and lagging hold back the soil around the outside of the excavation. The shoring system was designed by an engineer who specializes in this kind of work, and each I-beam's length was specified to fit site conditions and avoid waste. This system protects adjacent buildings from soil

subsidence and ensures a safe workplace for construction of the underground structures. It also provides the largest possible footprint for the new parking garage - without shoring, the excavation side-walls would need to be sloped back, resulting in an impractically small parking garage. The soldier piles consist of I-beams set into vertical boreholes, and the boreholes are then filled with a special sand-cement mixture, just like setting a post in a picket fence, only much bigger. Once the soldier piles were installed, excavation began just inside of the lines of piles. As this perimeter excavation is deepened, the lagging planks are dropped into place, so that there is never more than 12 inches of bare soil exposed, and that only for a short time, to help prevent cave ins during installation.
