# BUILDING UPDATE

## Construction Begins!

Annunciation  
Cathedral • 2013

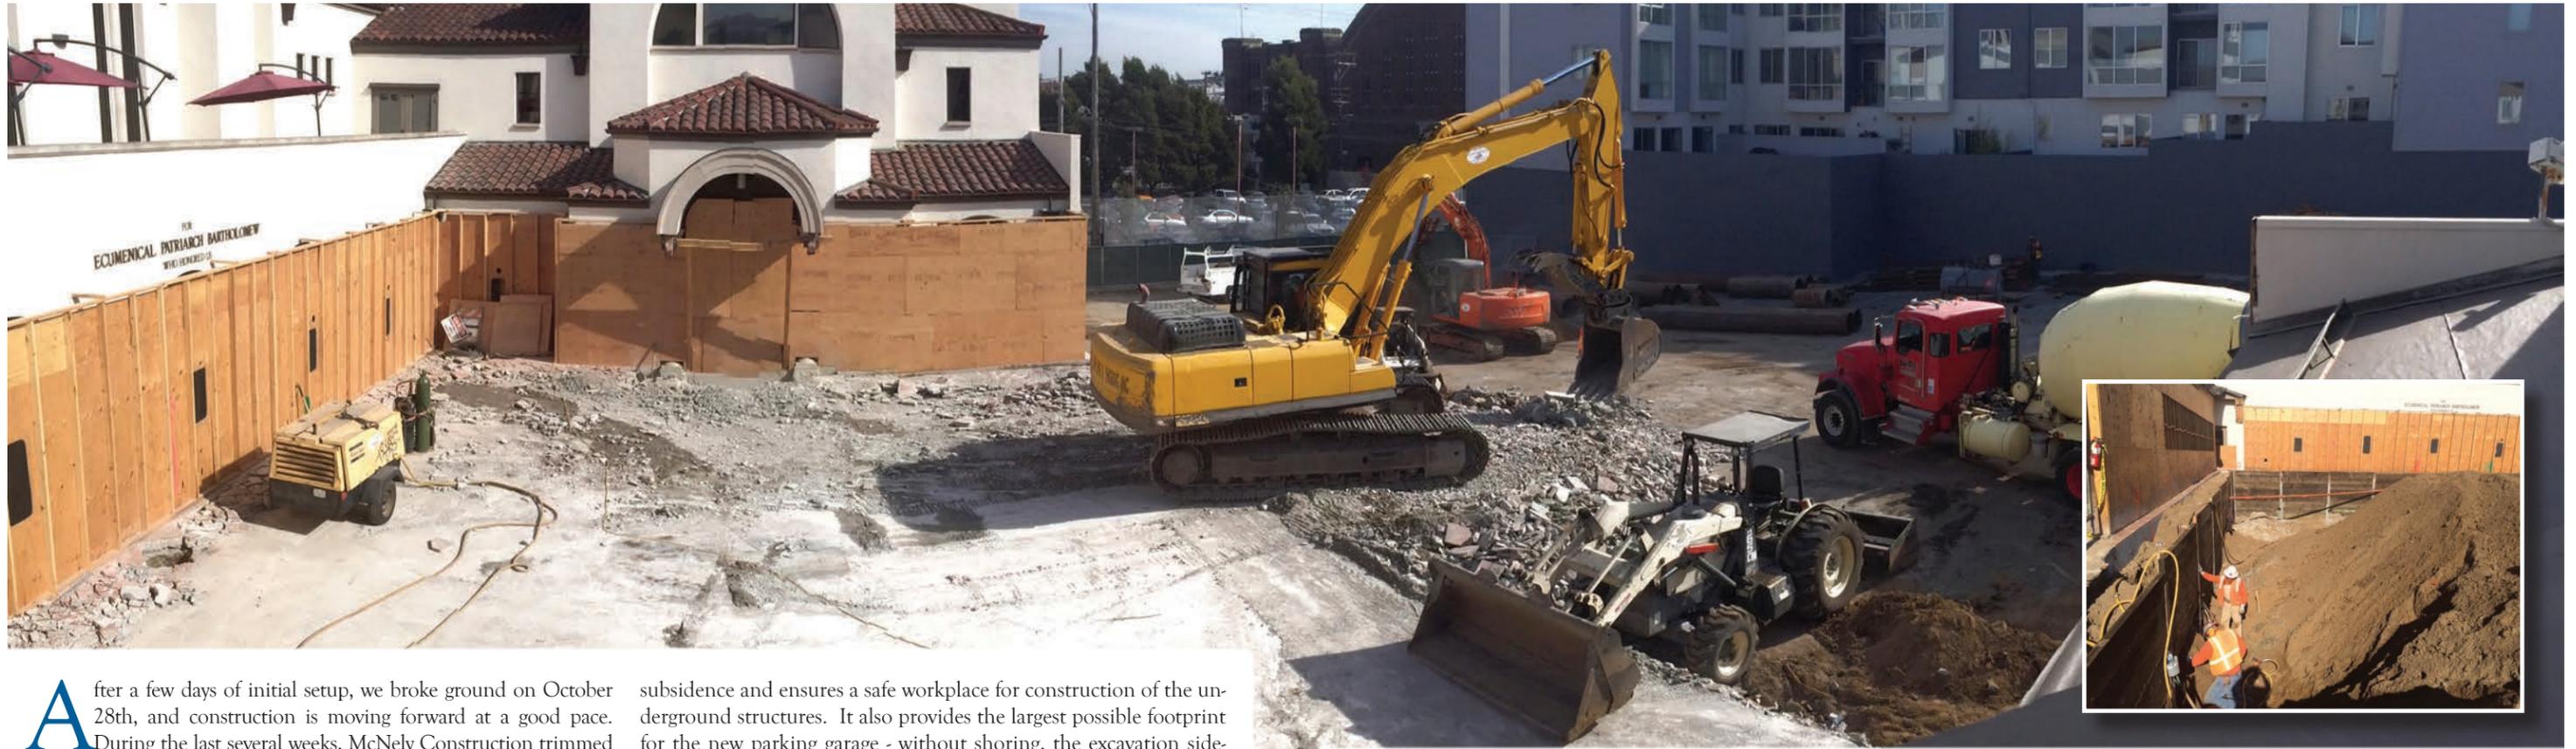
After a few days of initial setup, we broke ground on October 28th, and construction is moving forward at a good pace. During the last several weeks, McNely Construction trimmed back the covered outdoor walkway, and Granite Drilling and Shoring removed the tile from the courtyard and steps and demolished the concrete courtyard slab, steps, and half walls. They also removed the parking lot asphalt together with the parking lot lights and their concrete bases, and the fence along Stevenson Street was removed and replaced with a construction fence. During the demolition, the various materials were kept separated so that the maximum amount possible could be recycled (concrete and asphalt rubble are processed to make recycled aggregate rock for use in new concrete or under new asphalt pavement, metal can be recycled, and clean soil can be sifted and used at other sites that need fill clean fill). Recycling facilities charge less to dispose of materials than landfills, and maximum recycling was taken into account when the contractor developed the final demolition and excavation costs.

While the site demolition was progressing, Granite also set all 59 soldier piles for the shoring system. The shoring system is a kind of retaining wall, consisting of soldier piles with wooden planks (lagging) between each pair of piles; together the piles and lagging hold back the soil around the outside of the excavation. The shoring system was designed by an engineer who specializes in this kind of work, and each I-beam's length was specified to fit site conditions and avoid waste. This system protects adjacent buildings from soil

subsidence and ensures a safe workplace for construction of the underground structures. It also provides the largest possible footprint for the new parking garage - without shoring, the excavation side-walls would need to be sloped back, resulting in an impractically small parking garage. The soldier piles consist of I-beams set into vertical boreholes, and the boreholes are then filled with a special sand-cement mixture, just like setting a post in a picket fence, only much bigger. Once the soldier piles were installed, excavation began just inside of the lines of piles. As this perimeter excavation is deepened, the lagging planks are dropped into place, so that there is never more than 12 inches of bare soil exposed, and that only for a short time, to help prevent cave ins during installation.

Early in the demolition and shoring activities, several small investigation trenches ("potholes") were made to verify various subsurface conditions. These potholes confirmed the presence of an electrical conduit running diagonally under the courtyard and confirmed that the foundations of the existing chapel are poured concrete in excellent condition (which allows us to avoid installing potentially costly waterproofing and drainage for the foundation). Potholing has also uncovered the soldier piles from the construction of the new building next door that are partially on the Cathedral's property. This is not unusual - shoring is usually left in place after construction, since there is generally no way to take it out without damaging the any adjacent new or existing buildings. It is not unusual for soldier piles to extend to - or even a bit beyond - a property line, and where they interfere

One unwelcome piece of underground news was confirmation of the presence of a three- to five-foot thick layer of debris dumped onto the property after the 1906 earthquake and fire. This is not an unusual condition throughout the Mission District; our property was a water park in the late 1800's, and Mission Creek still flows (underground) adjacent to the Cathedral. This century-old debris is unsuitable for soil recycling, and will have a higher disposal cost. Unfortunately, the debris included lots of painted wood (from structures that were demolished or burned in 1906) that was painted with lead-based paint (the only kind they used a century ago). The wood has largely rotted away, leaving the lead behind as microscopic particles mixed in with the rest of the debris, which are too small to sift out of the debris. This lead contaminated debris will have to be taken to other disposal sites that are permitted to accept such waste, and which costs more than normal disposal or recycling. The levels of lead contamination vary across our site, and not all of the earthquake debris will need to go to the more expensive disposal sites.
